Rigney Home Inspection Report

**Report Prepared For:
Client**

**Report Prepared By:
Mike Rigney**

October, 2004

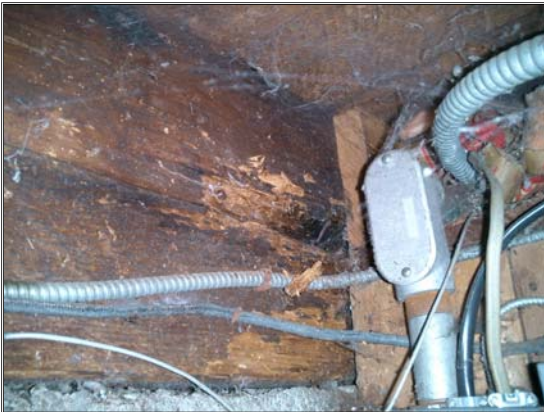
Beetle damage

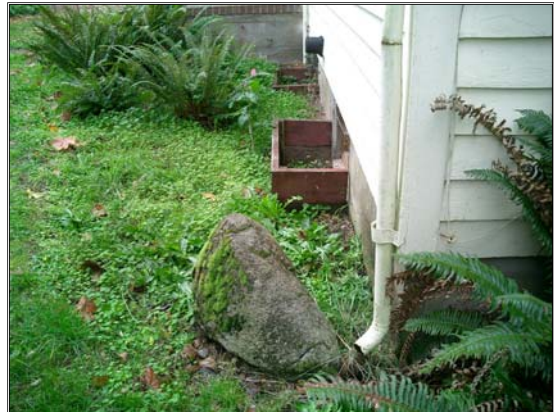
In regards to proper slope configuration and drainage, the landscaping of this home has some issues. The yard around this structure needs to be configured so that the soil immediately next to the foundation slopes away on all sides no less than 1 inch per foot for at least the first six feet from the foundation. This is to ensure that runoff will drain well clear of the foundation before seeping deep into the ground where it can infiltrate basements and crawlspaces or saturate the soil beneath a slab. As presently configured, this yard will drain toward the foundation, conveying an unacceptable amount of runoff toward the foundation. We recommend having this corrected by re-grading the yard around the home. A professional landscaper or drainage contractor should be consulted to discuss options and cost.

Grade toward foundation
